Manhole Inspection Summary

Manhole # S49GG_012MH

Insp Date: **8/11/08 12:13 PM**

Location Address: **Milton**

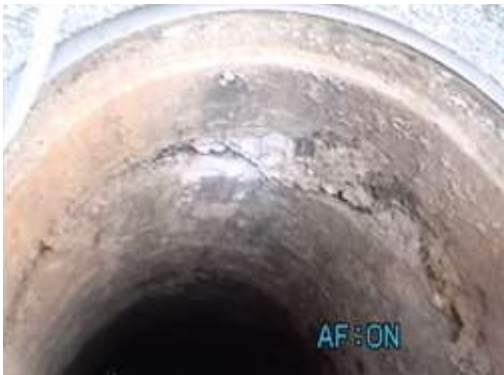
Defect 2

Frame Offset: **2** (in.) Condition: ☒ Sound ☐ Cracked ☐ Leaks

frame leaks

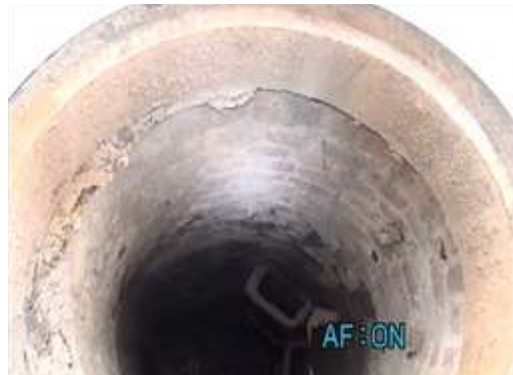
Defect 1

Infiltration: ☐ None ☒ **Joint** ☐ Cracks ☐ Mortar ☐ Roots ☐ Wall

Infiltration: ☐ None ☐ Joint ☐ Cracks ☐ Mortar ☐ Roots ☒ **Wall**

Infiltration

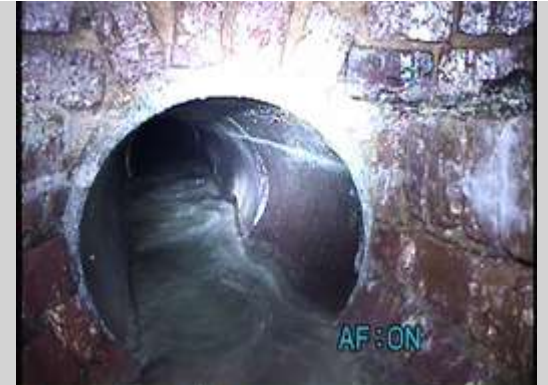
12 O'Clock Outflow

12 in. Circular Gravity Sewer
Pipe Out @ 12 O'Clock

Pipe Height: **12** (in.) Rod and Bar (Angled)
Pipe Material: **Clay** ☐ Pipe Lined
Invert Depth: **16.90** (ft.) Flow Characteristics: **Fast**
Deposits: ☒ None ☐ Mud ☐ Sludge ☐ Debris ☐ Grease
Silt Depth: (in.) Deposits Extent:
Infiltration: **None** Pipe Seal Cond: **Sound**

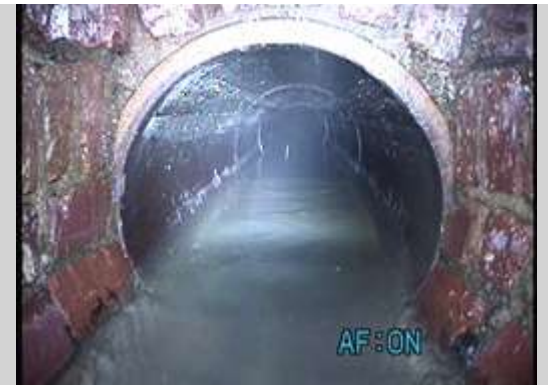
7 O'Clock Inflow

12 in. Circular Gravity Sewer
Pipe In @ 7 O'Clock

Pipe Height: **12** (in.) Rod and Bar (Angled)
Pipe Material: **Clay** ☐ Pipe Lined
Invert Depth: **16.80** (ft.) Flow Characteristics: **Fast**
Deposits: ☒ None ☐ Mud ☐ Sludge ☐ Debris ☐ Grease
Silt Depth: (in.) Deposits Extent:
Infiltration: **None** Pipe Seal Cond: **Sound**
